Report on the Rainwater harvesting project Mwoyoweshumba Primary School Mutasa District, Zimbabwe

Report prepared by:
Lynn McGoff and John Mullett
Sustainable OneWorld Technologies C.I.C. (SOWTech)
Sandile Mtetwa and Admire Baudi
Bolsan

February 2020

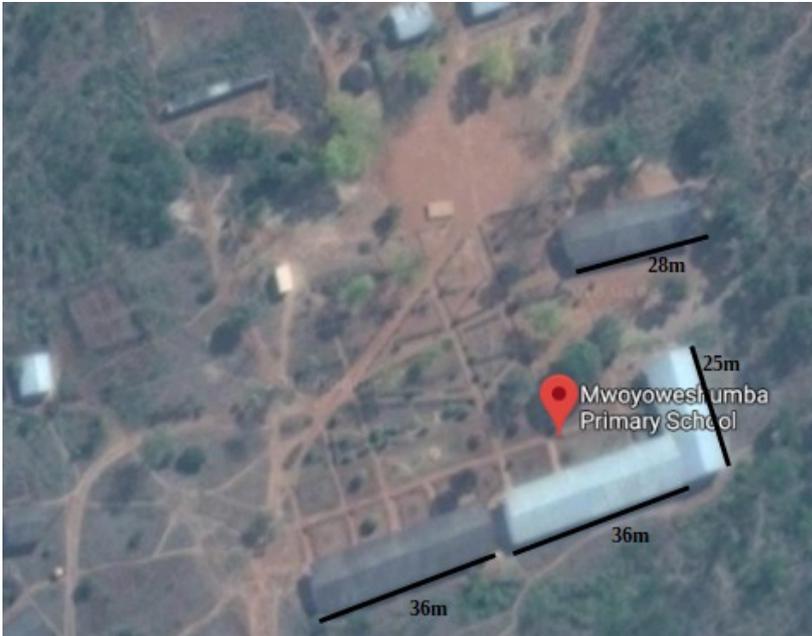
The school has a number of different buildings including classrooms and an administration building. The buildings contain more than one classroom and are therefore too long to be used as a pilot project. It was therefore decided to use one end of a classroom building roof to demonstrate the system.

Approximate lengths of school buildings shown

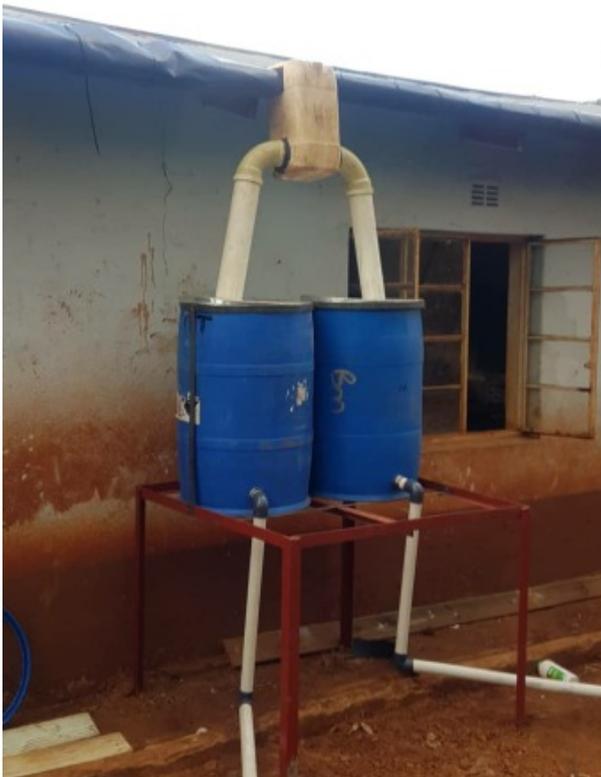
Wrap-round gutters made from polyethylene (PE) were attached to the edge of the roof. These were to collect the rain it falls and runs down the roof. They then direct the rainwater to each end of each gutter where the water is directed into buffer tanks through large bore pipes to remove the water quickly from the roof area.

The buffer tanks were locally-sourced and are mounted on raised platforms so that the water can leave the buffer tanks under gravity without the need for pumps. The buffer tanks have a volume of around 0.5m³ to accommodate the rain from a single downpour during the rainy season.

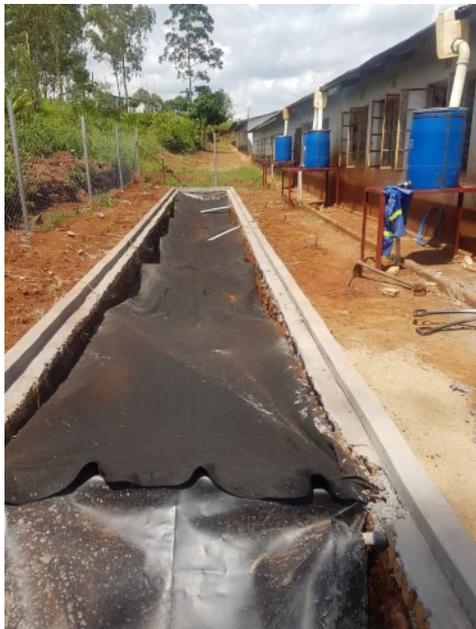
Using rainfall figures from a weather station in Mutare it was calculated that the annual rainfall is around 790mm, the majority of which falls in the months of October to March. Calculating the amount of rain predicted to fall in the rainy season on a classroom roof of size 12m x 10m gives a figure of 85m³. This gives a mean daily rainfall of about 15mm. As each storm lasts about 1 hour the assumption was made that

15mm of rain will fall in one hour. Using the above assumptions each gutter will collect 0.9m³ of water per day. The buffer tanks were therefore sized to accommodate this amount of rainwater.

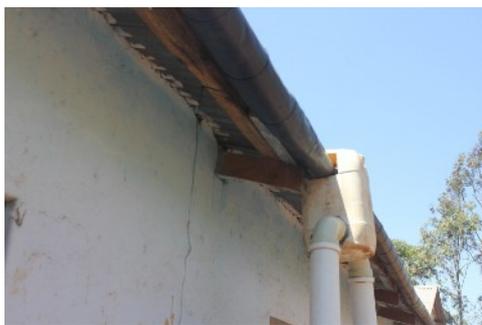
The IRH system was installed by Zimbabwe Africa Trust in November 2018, in time for the wet season. The trench was dug and the IRH tank was installed into it. Specialist cable ties had been provided to lift and hold the tank in place. These proved to be problematic and modifications were made using rope and plastic washer type reinforcements behind the rope.

The button cable ties supplied for the holding up of the tank tank when in the trench were unsuitable for the purpose. The people installing the tank had devised a method using rope loops with plastic washers behind. This has proved to be successful and will be refined and incorporated into future designs.

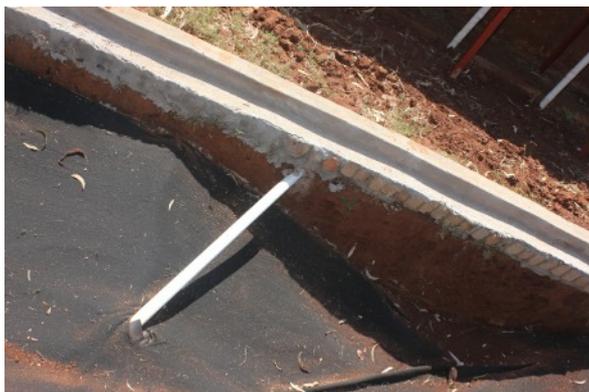
The supplied tank was in a geotextile "sock". The tank itself had small slits in the top to allow rain landing on the tank to go into the tank. If the rain was allowed to sit on the top the weight of the water could cause the tank to cave in. There were no slits in the geotextile to prevent insects and debris entering. The plan was to have the water input and output pipes go into the ends of the tank where the lid was not sealed. When the tank was installed slits were put into the geotextile and the input pipes pushed through. This increased the size of the holes and can allow debris and insects to enter the tank.

One way of preventing that happening would be to cover the top of the tank with a sloping impermeable layer to prevent rain falling onto the tank. Having a sloping roof would allow the rain landing on this roof to also be collected in gutters and fed into the tank.

A roof in sections is proposed so that it is easier to handle and the whole roof doesn't have to be removed to access one part of the tank. The choice of materials to use could be site specific.

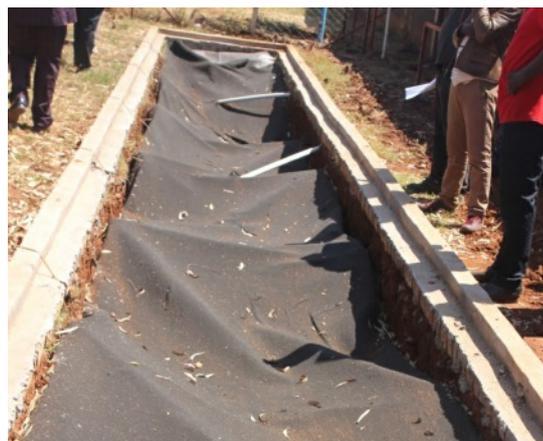
The tank was designed to have the input and output water pipes inserted at the ends of the tank. However due to having increased the number of buffer tanks which were located at a number of positions alongside the tank rather than a single one at the end of the roof it was deemed more cost effective to connect the buffer tanks to the storage tank with the shortest run of pipework.

This is an issue that needs further work to be done especially if longer tanks are installed. The roofing of the storage tank may be a solution.

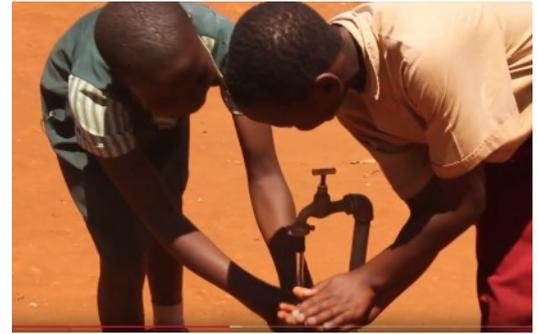
Currently the water is being taken directly from the tank for a number of uses. These include drinking, toilets, bathing and watering plants. The water has been connected to a tap so it can be easily accessed. Whilst it is really good that the water is being used there is concern that it is being used as drinking water without further treatment. Whilst it is obviously cleaner than that taken from a river it cannot be guaranteed to be free from contaminants and disease. It therefore needs to undergo a treatment process before being drunk. SOWTech and Bolsan are looking into options for water purification that can be offered as part of the system.
