# Durability of Butyl fabrics in the Tropics

Technical Article: TA20

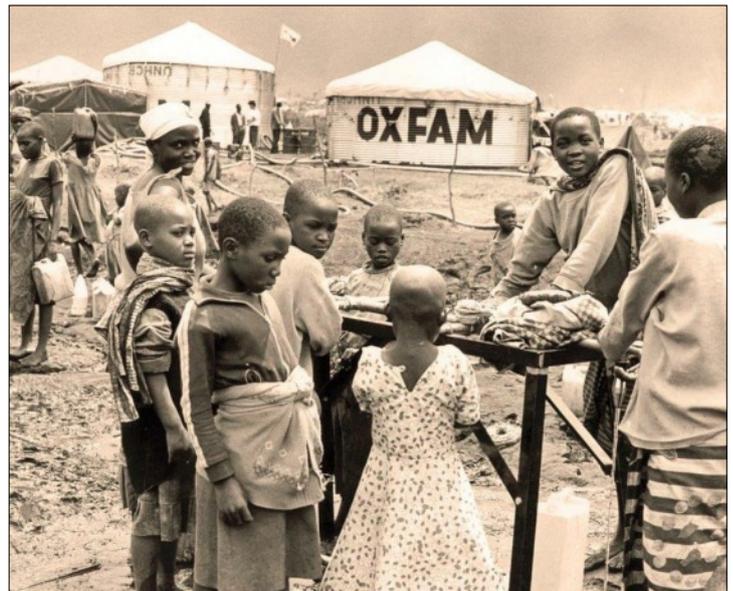
Top: Butyl lined water tanks supplied to Oxfam approximately 30 years ago

One of the best examples of this track record can be found in the field of demountable water storage tanks. These products have been supplied by Butyl Products Ltd for many years. The lining of these tanks has been made from Butyl rubber, and in many instances they have been exposed and uncovered to the elements during their operational life. The photo below shows a water storage tank still in use 13 years after installation. As can be seen from the photo tank is still watertight and not showing any obvious degradation.

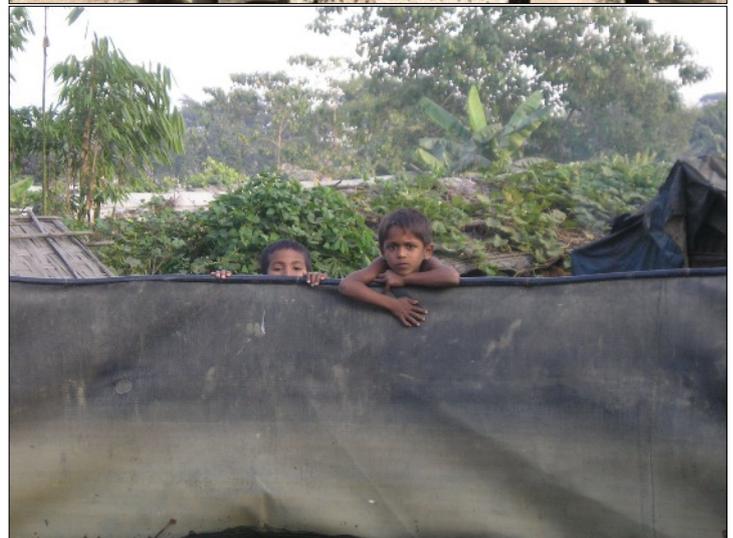
Bottom: Butyl lined water tank supplied to a Bangladesh refugee camp. Photo taken 13 years after installation.

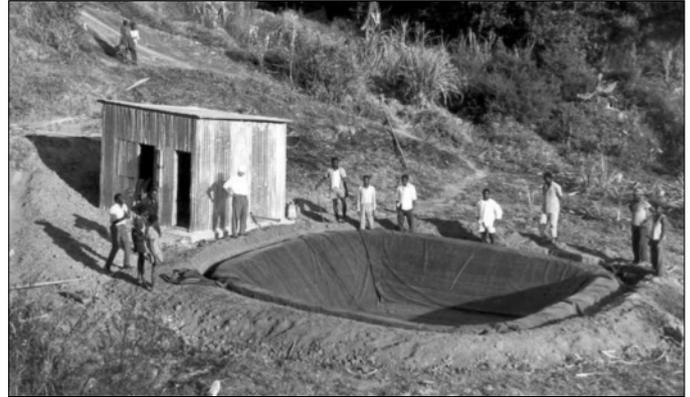
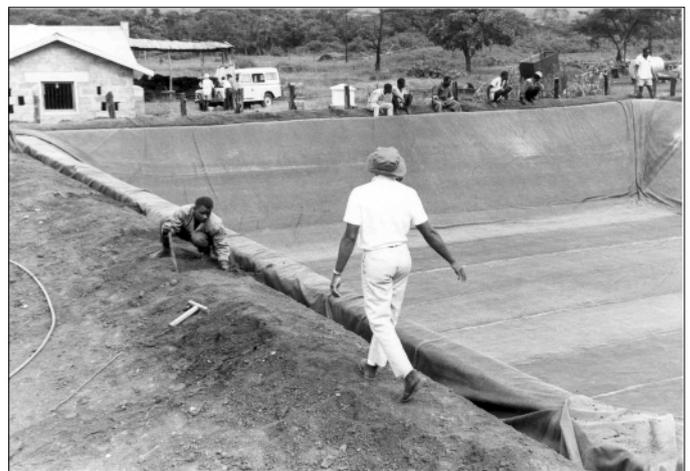
Top and middle right: Butyl lined sewage tank and water reservoir being built as part of aid activities

Butyl as a material has also been widely used for the purposes of lining reservoirs and large lagoons. The attached photos illustrate the material being used in these applications, and they would clearly not be appropriate, if they were to be vulnerable to chemical or ultraviolet degradation.

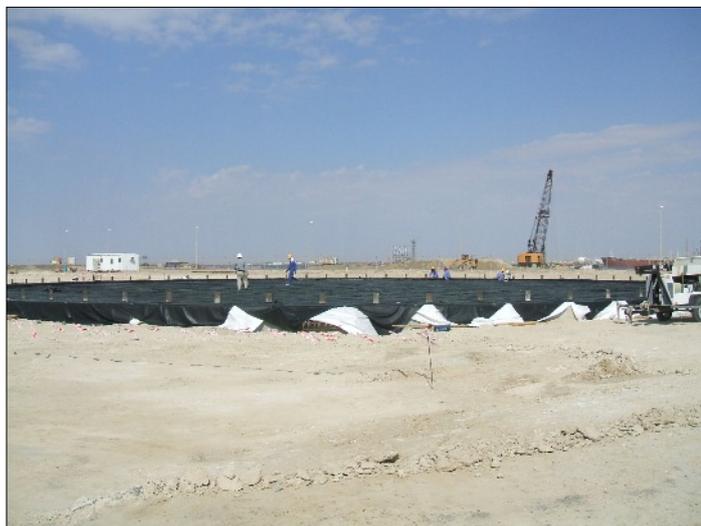
Bottom left: Butyl lined tank being built in Saudi Arabia (Whessoe) 2007

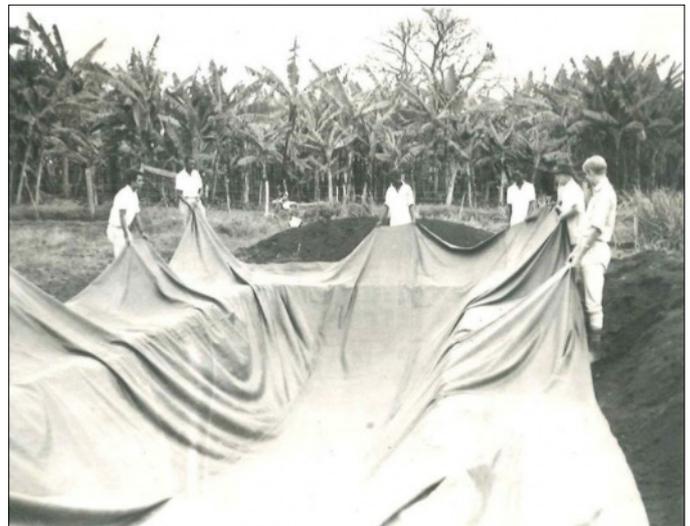
Bottom right: Irrigation pond liner being installed for sugar seedlings in 1967
